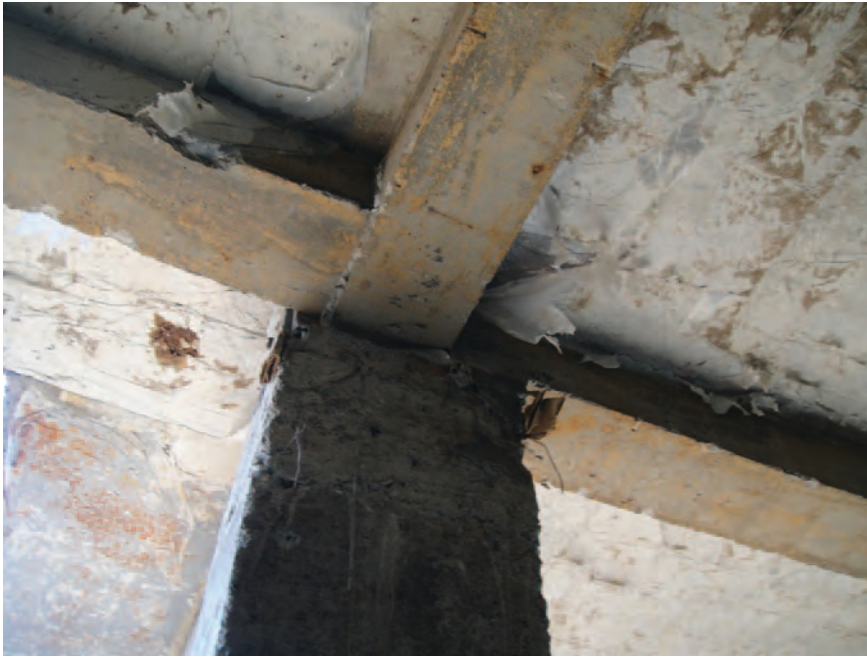
Figure 13. Reinforced concrete columns used for new constructions are of incorrect cross section and do not have adequate reinforcement.

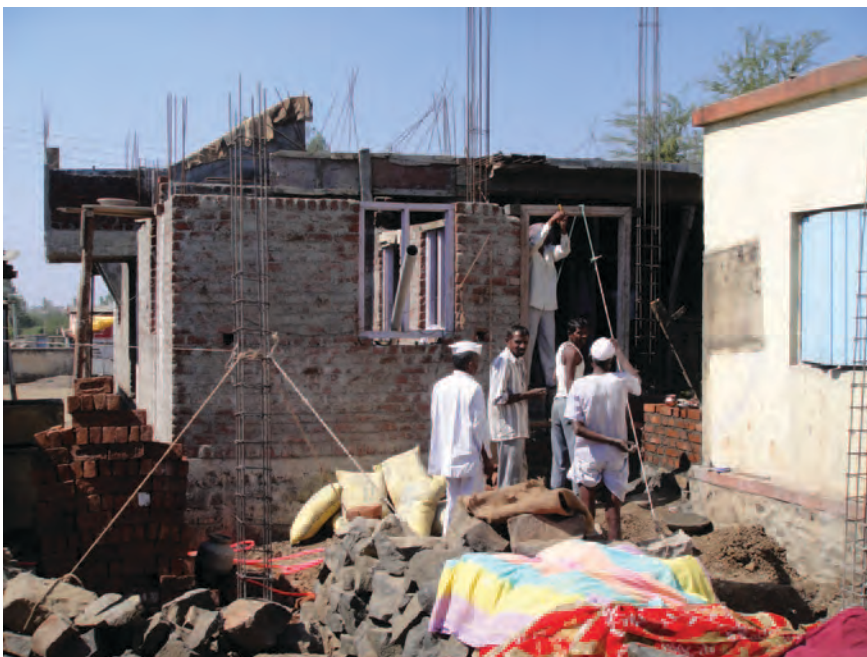
Figure 14. The new constructions in brick and reinforced cement concrete are of very poor quality.
