MRSE 2573 INTEGRATED OCCUPATIONAL, SAFETY AND HEALTH MANAGEMENT

GROUP CASE STUDY

-TUNNEL CONSTRUCTION TRAGEDY -

PUDU UNDERPASS PROJECT – UNDERGROUND TUNNEL COLLAPSE

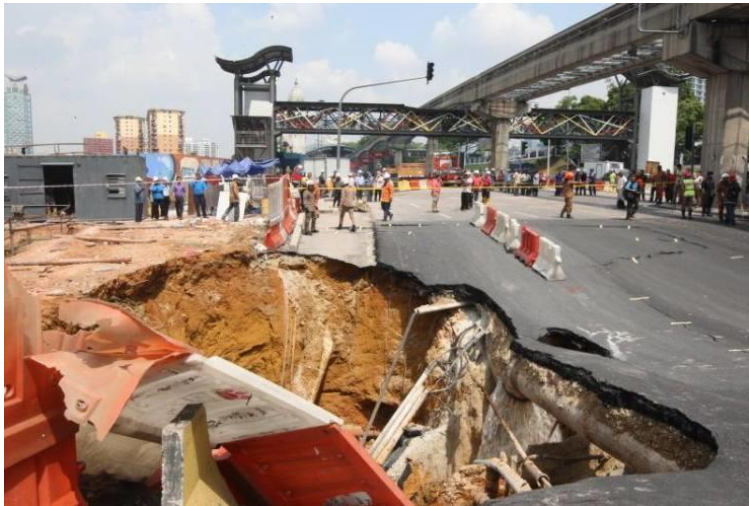
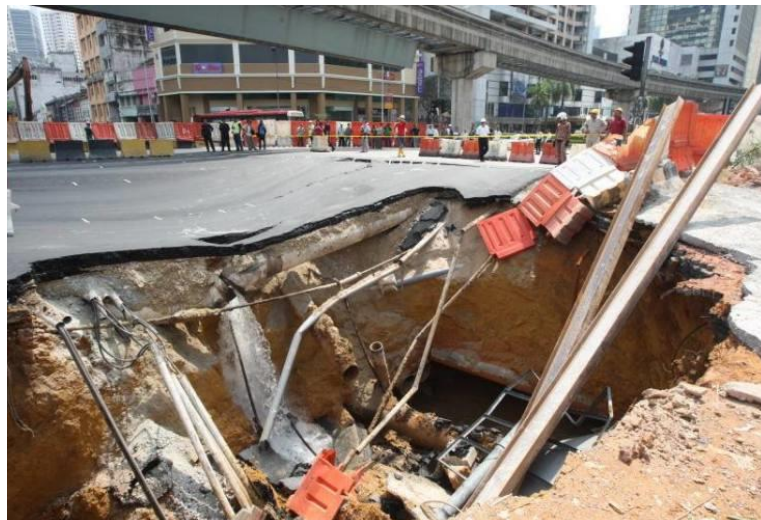
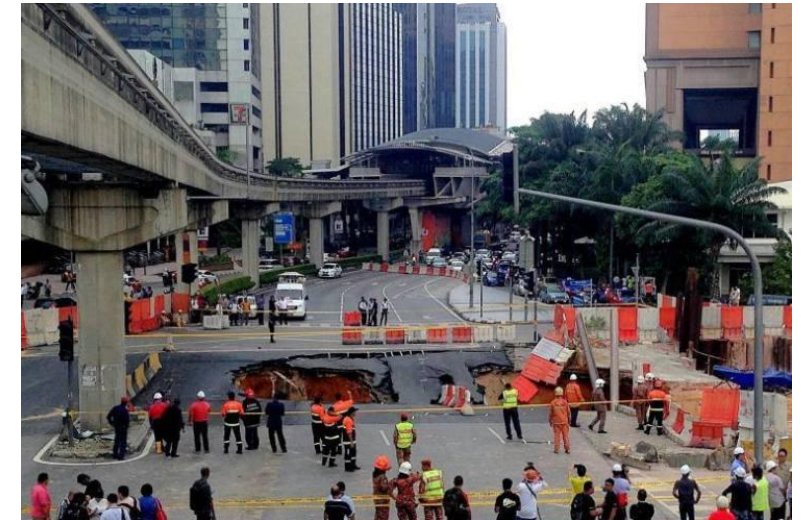
- Tragedy Year : July 2014
- Sunk twice - 10.38am and 12.20pm
- We predict that the road will collapse further along the tunnel line.
- The collapse has damaged Syabas water pipes.
- It is learnt that two idle excavators were in the tunnel when the incident occurred but no casualties have been reported.

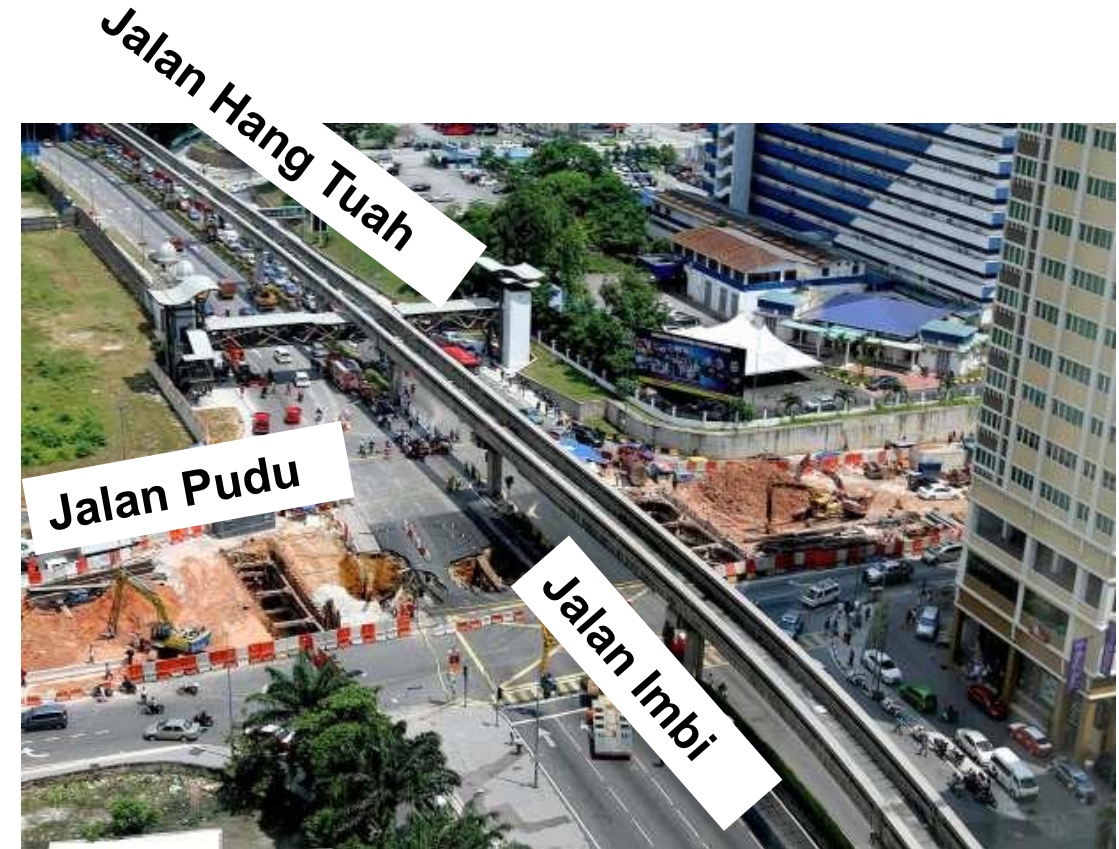
- Traffic jam at Jalan Pudu and Hang Tuah
- Roads closed for 2 weeks
- Monorail Service between Imbi and Hang Tuah station halted
- Damage SYABAS water pipe
