Taklimat Teknikal Kegagalan Tangki Air GFRP SMK Paka

Dr. Shukur Hj. Abu Hassan
Centre for Composites (CfC) UTM

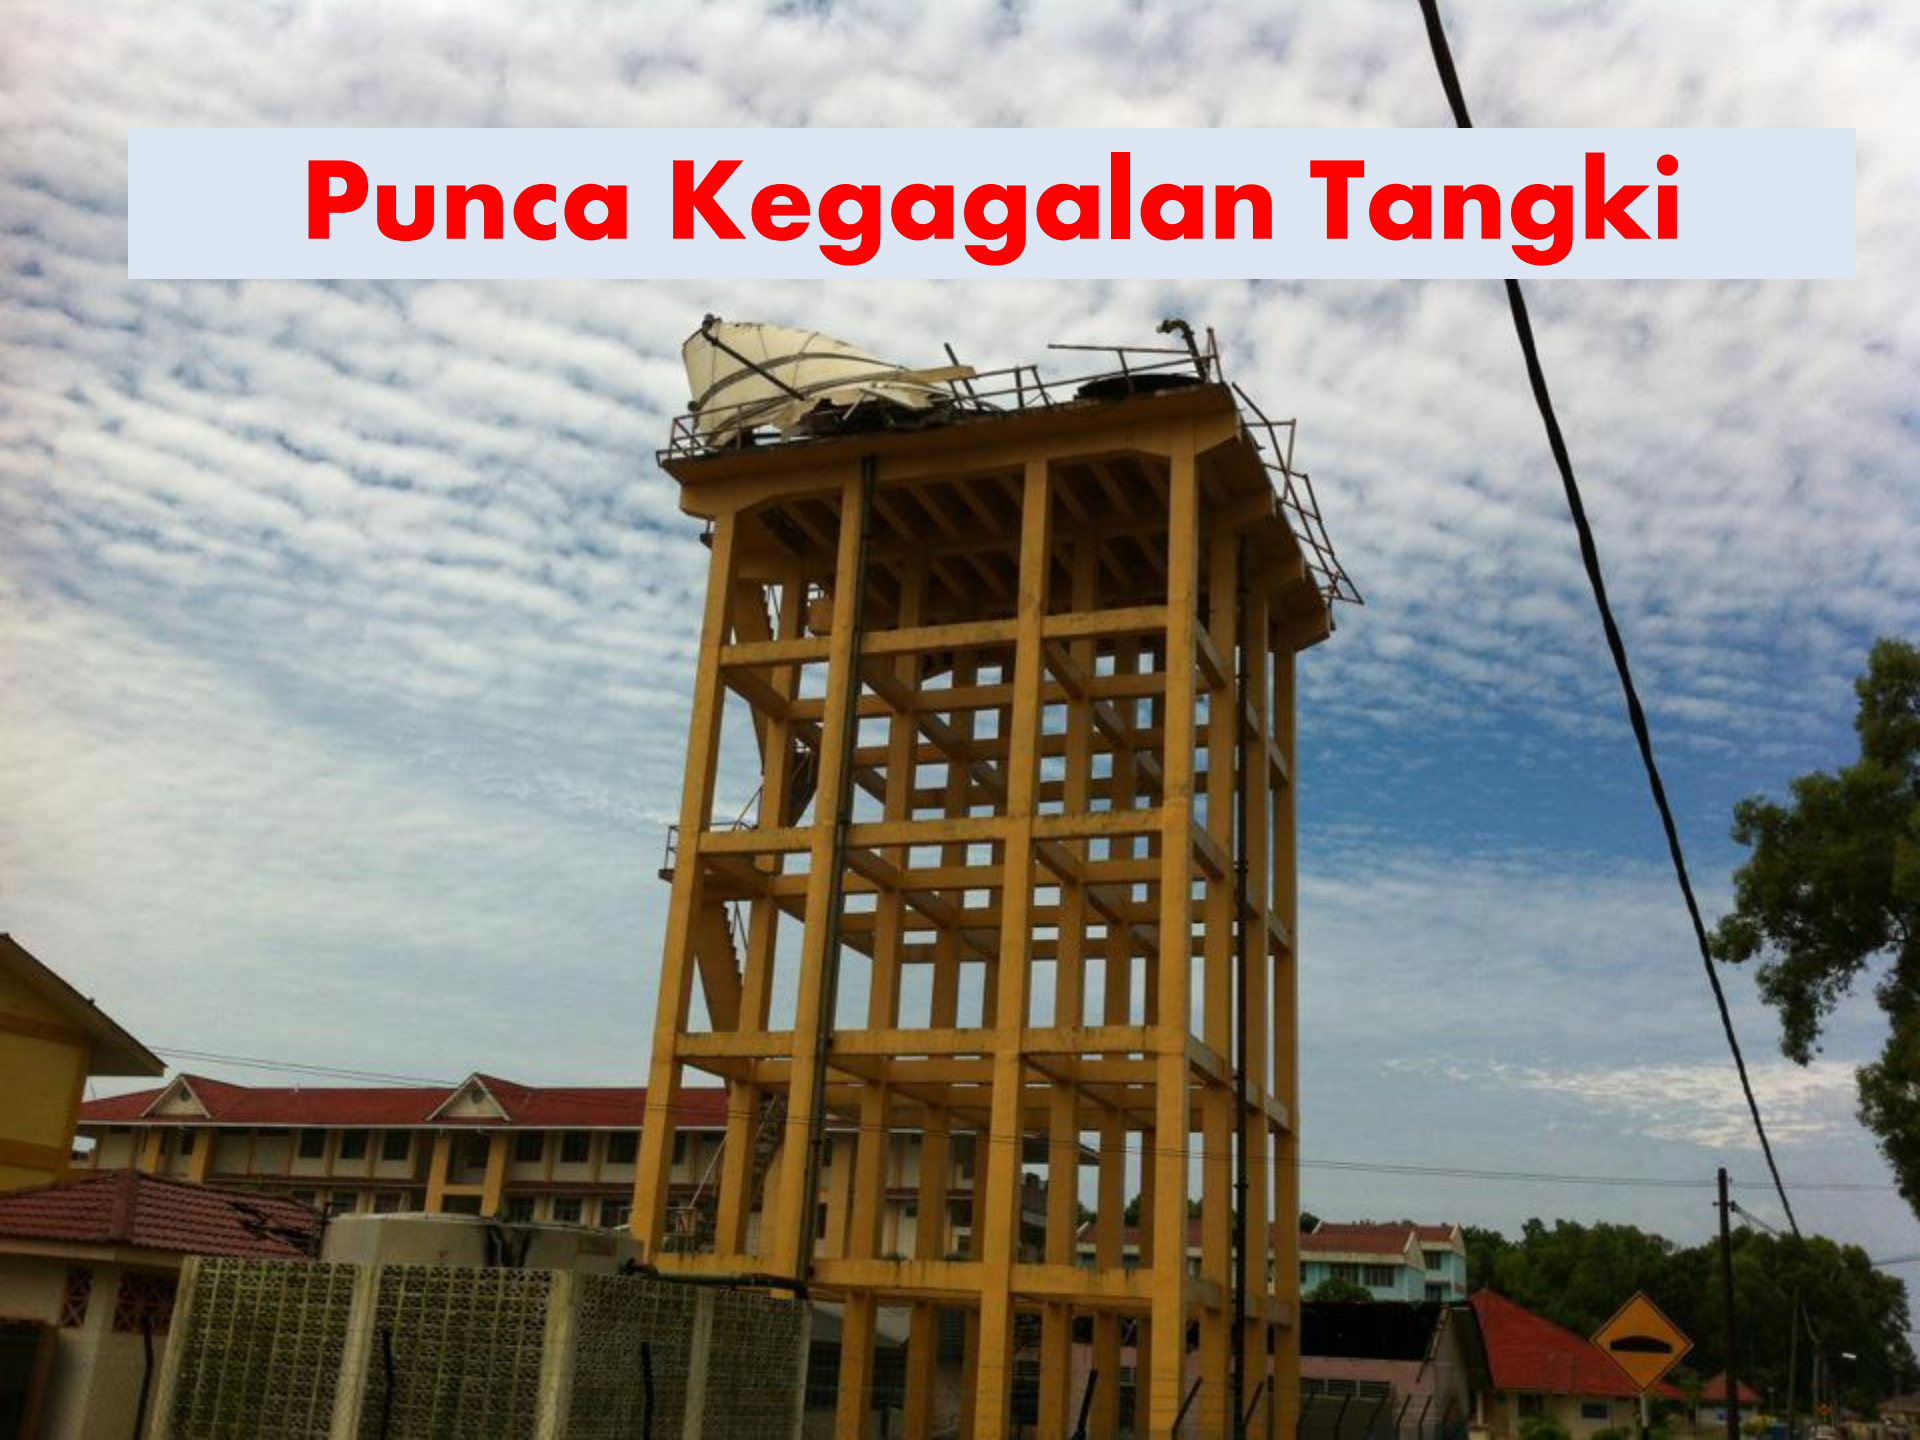
- **Kaedah Pembuatan Tangki (Tank Construction)**

- Poor wall to wall joint

- Poor wall to bottom joint

- **Kualiti Antara-Permukaan Laminasi (Laminate Interface Quality)**

- Poor surface preparation at site

Invite moisture/water to ingress within laminate joint interface

In long-term operation, this could produced debonding between the laminate (i.e. **between primary laminate and secondary laminate**) that will deteriorated structural integrity.

- Resin weak/lost (reduced stress transfer from fibre to fibre)
- Hydrostatic pressure (hoop and lateral stresses) that accelerate the crack/debonding (failure) process

- **Poor external and internal surface coating**
 - Microcracking on wall surface due to poor coating (gelcoat). No maintenance or regular inspection during service. Hot/wet tropical weather accelerates the process of defect.
 - Water/resin diffused into internal surface
 - Unsealed edge (wall bottom and some other parts of the tank). Study shows, reduction of about 11% of flexural strength and modulus in 300days immersed/exposure to water (moisture ingress)

- Tangki-tangki menggunakan konsep pembuatan Atostech2 adalah dianggap tidak lagi selamat dan amat merbahaya (**red alert**) berdasarkan kepada tahap pemerhatian kepada kes kes sebelum ini melalui sampel sampel yang telah gagal.
- Bina tangki baru
