SHARING CONSERVATION DECISIONS

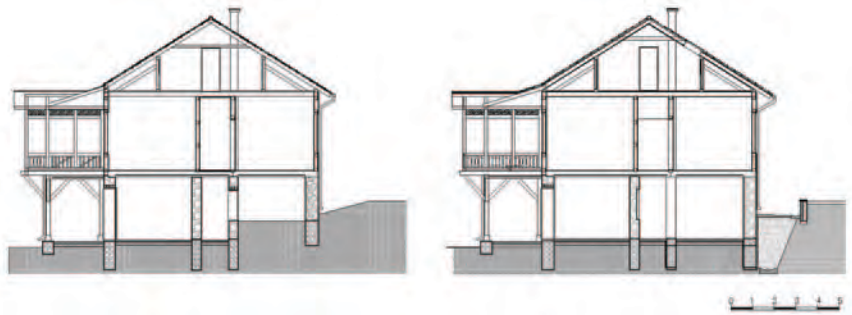
Figure 3. Cross-section before and after reconstruction.

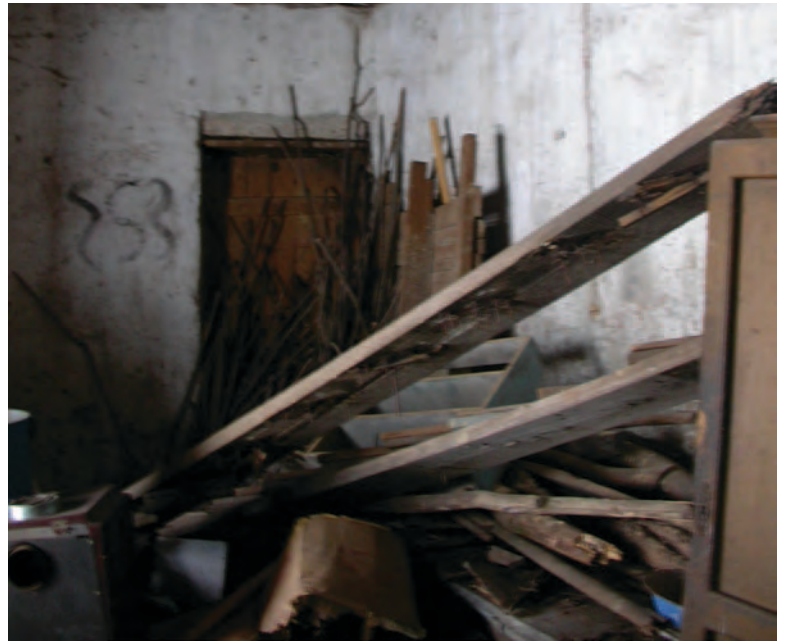
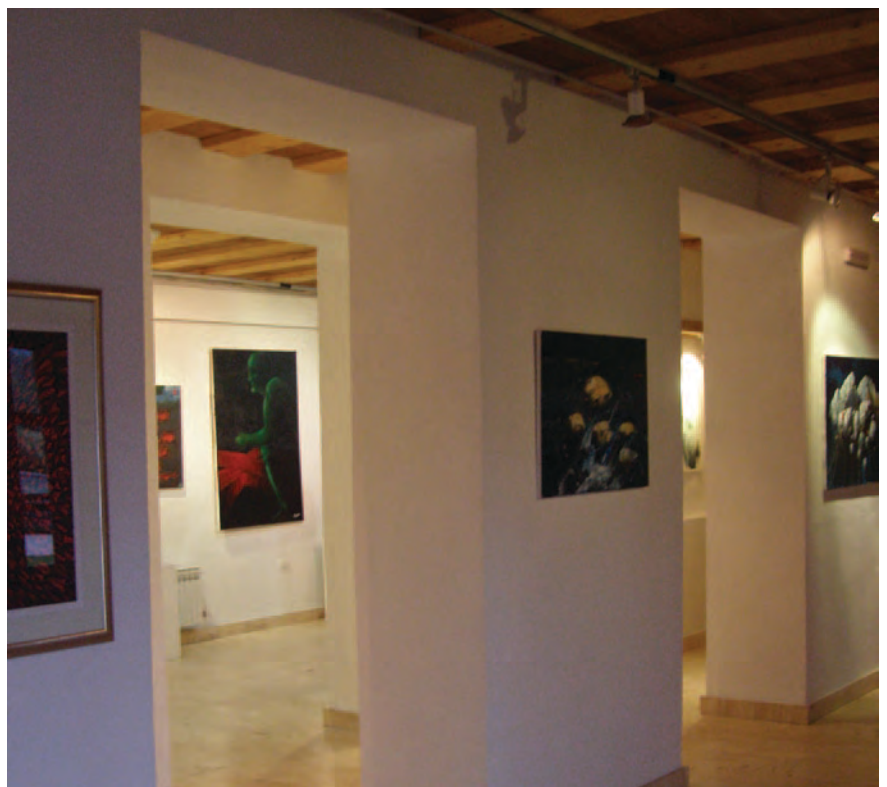
Figure 4. Basement (a) before, and (b) after restoration. Photo Milijana Okilj.
