Impact of reconstruction: increasing vulnerability (1993–2011)

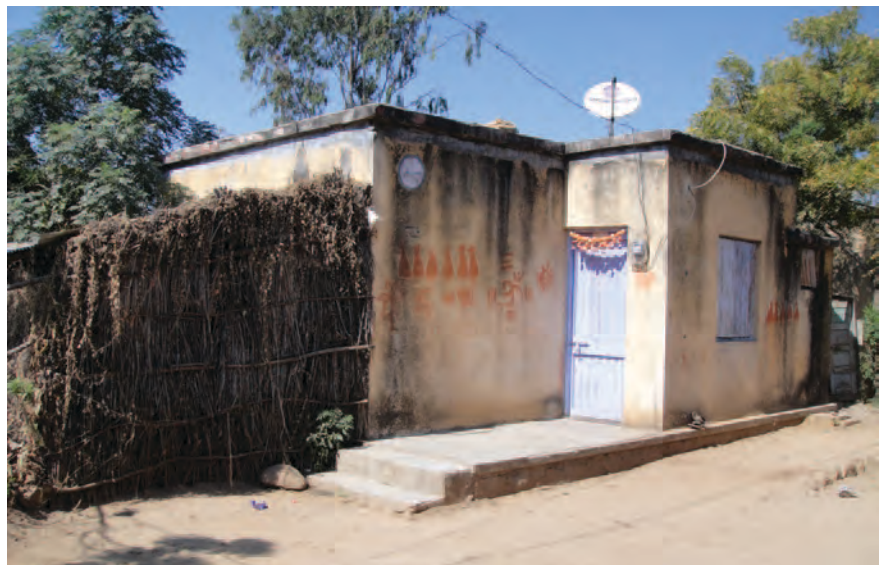
Figure 7. The local people have made additions to the relocated houses using locally-available materials, such as thatch.

In relocated villages, people have undertaken extensions to their houses, but very few extensions have been carried out using the materials and technology that were originally promoted in the reconstructed houses because they are neither affordable nor available.³ Wall materials include tin sheets, thatch, ferro-cement sometimes with bamboo posts, and stone and brick in cement mortar.

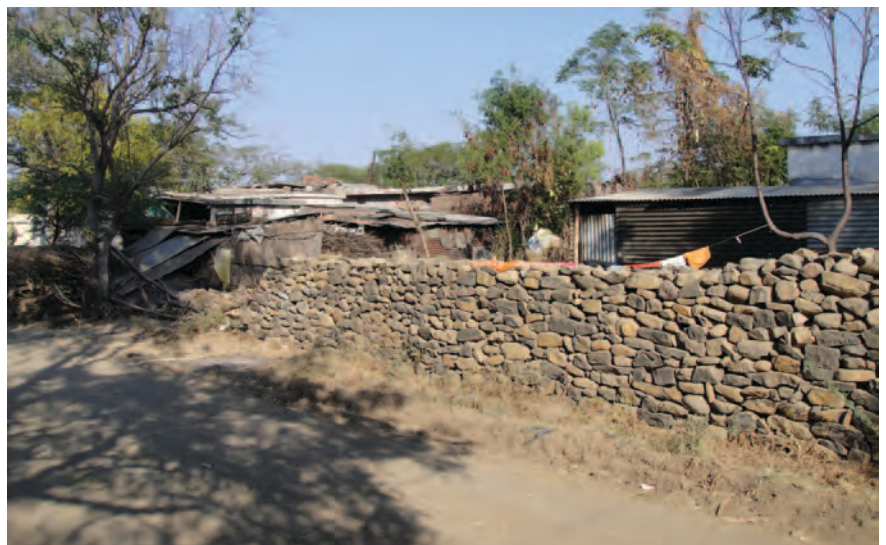
Figure 8. Stone in random rubble masonry is only used for making boundary walls.

While stone was the predominant building material of traditional houses in the region before the earthquake, it is now used only to a very limited extent, mainly for the construction of boundary walls. This is because of a perceived fear of stone as an unsafe building material (Figures 7-10).⁴
