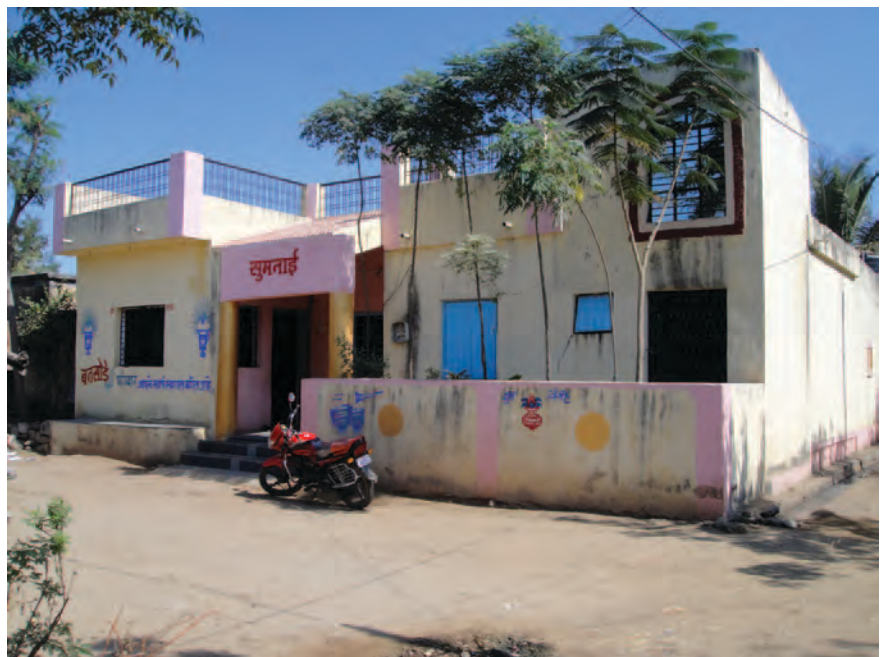
Figure 11. Community members from affluent socioeconomic backgrounds are significantly less vulnerable, as they have made additions using the same materials and technology as used in the reconstructed houses.

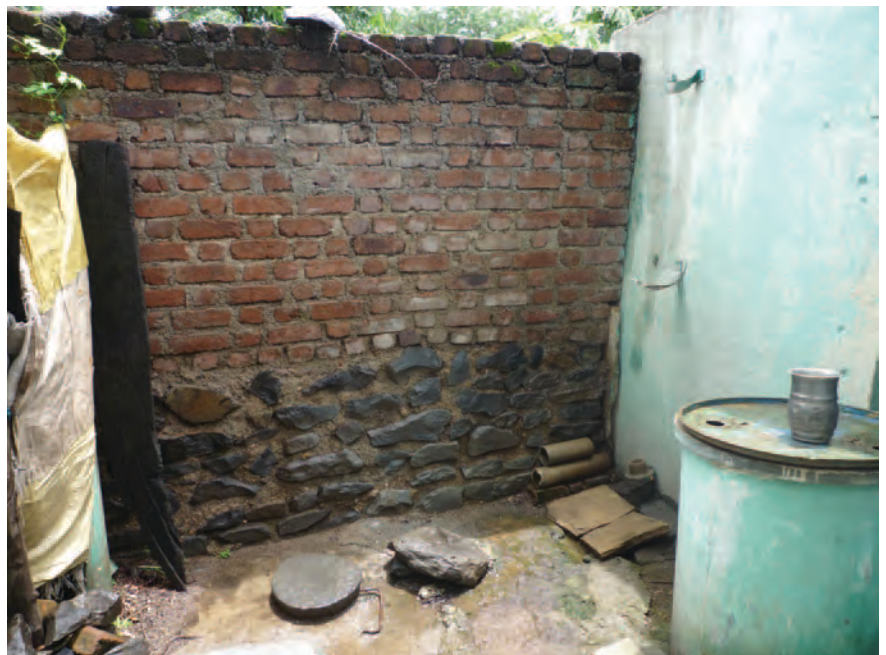
concrete columns, wherever used, are of improper cross section and do not have adequate reinforcement. In many instances, tin sheets used for roofing are not fixed to the purlins, but rather just held in place with stones, thereby making them susceptible to displacement in high winds, or leakage during heavy rains (Figures 11-14).

Figure 12. Many additions made for outdoor kitchens are in poor brick masonry, covered by tin sheets that can easily blow away during heavy winds.
