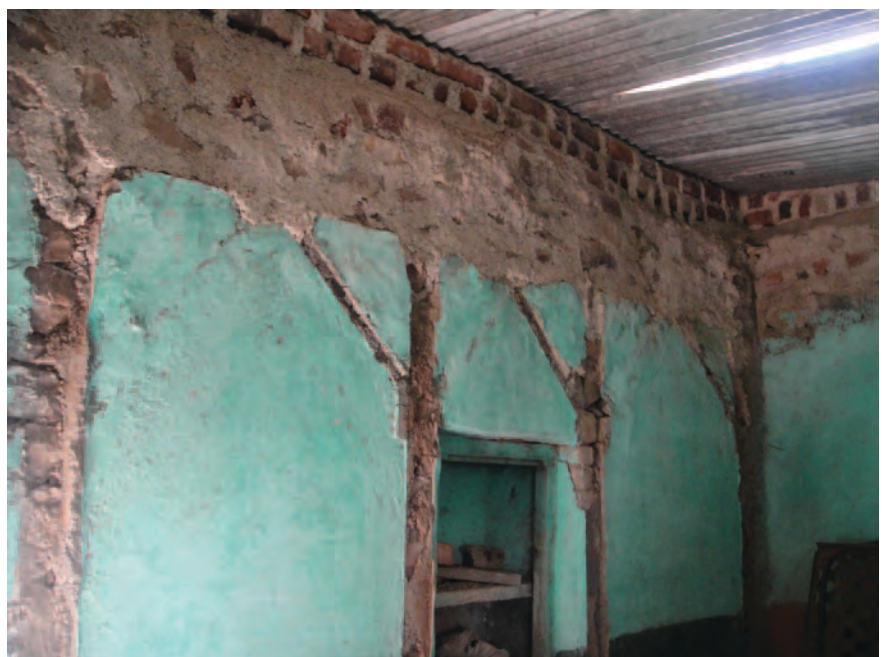
Figure 15. The iron angles used for retrofitting traditional houses have been removed to increase the ceiling height. Moreover, the traditional roof, made of wooden beams and rafters, is being replaced by tin sheets.

retrofitting and can only remember ‘angles’ as distinctive features of these houses that were put in place to strengthen the connection between the walls and the roof. In some of these houses, these angles have already been removed in order to increase the height of the roof. In others, extensions to these houses do not incorporate any earthquake-proof features (Figure 15).
