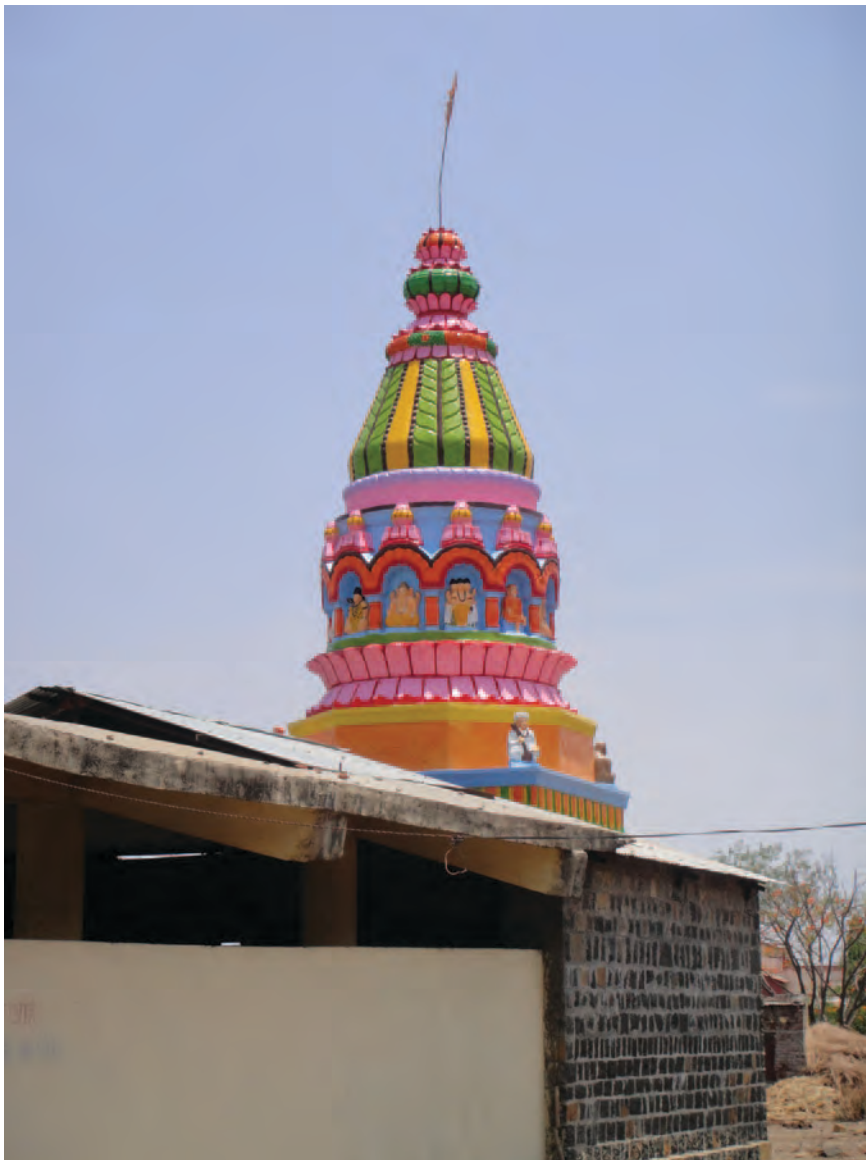
Figure 16. Traditional stone temples that were considerably safer against earthquakes have gradually been replaced with reinforced concrete structures of poor quality, built with new architectural techniques from the surrounding region.

use of traditional materials is so strong that wood salvaged by owners from their old houses is used as firewood and stones are only used for boundary walls. These perceptions have also led to the replacement of traditional stone temples, which were highly resistant to earthquakes, with ones constructed in brick and reinforced concrete. There is also a new architectural vocabulary influenced by nearby regions. Most of these new constructions do not follow any earthquake safety standards (Figure 16).
