MRSE 2573 INTEGRATED OCCUPATIONAL, SAFETY AND HEALTH MANAGEMENT

GROUP CASE STUDY

-TUNNEL CONSTRUCTION TRAGEDY -

PUDU UNDERPASS PROJECT – UNDERGROUND TUNNEL COLLAPSE

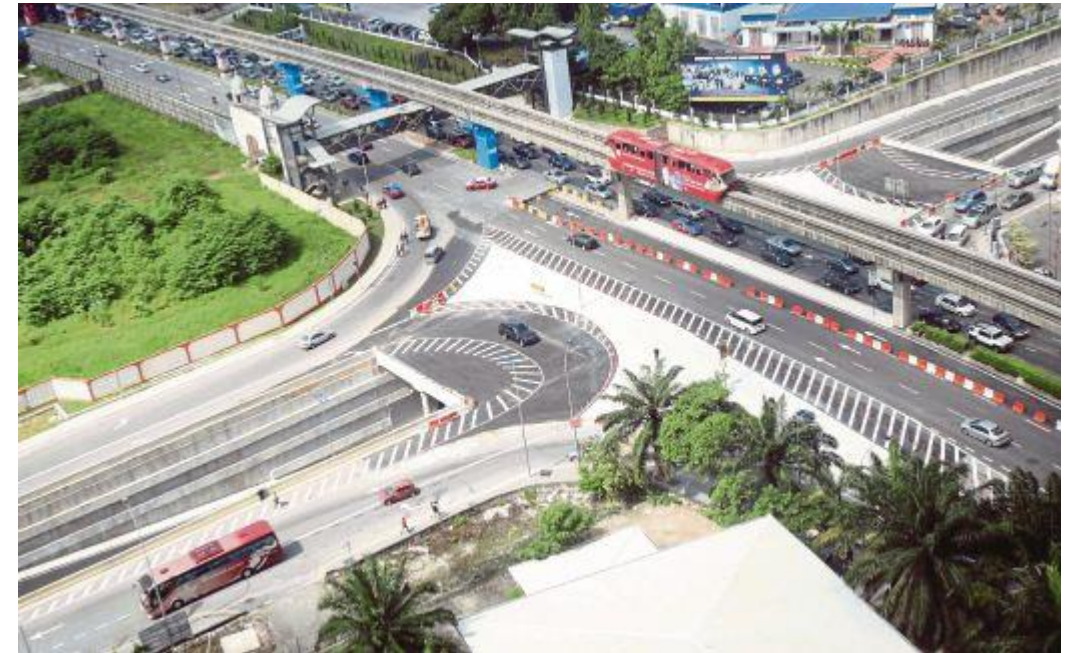
- Tragedy Year : July 2014
- Sunk twice - 10.38am and 12.20pm
- We predict that the road will collapse further along the tunnel line.
- The collapse has damaged Syabas water pipes.
- It is learnt that two idle excavators were in the tunnel when the incident occurred but no casualties have been reported.
