### Case studies<sup>2</sup>

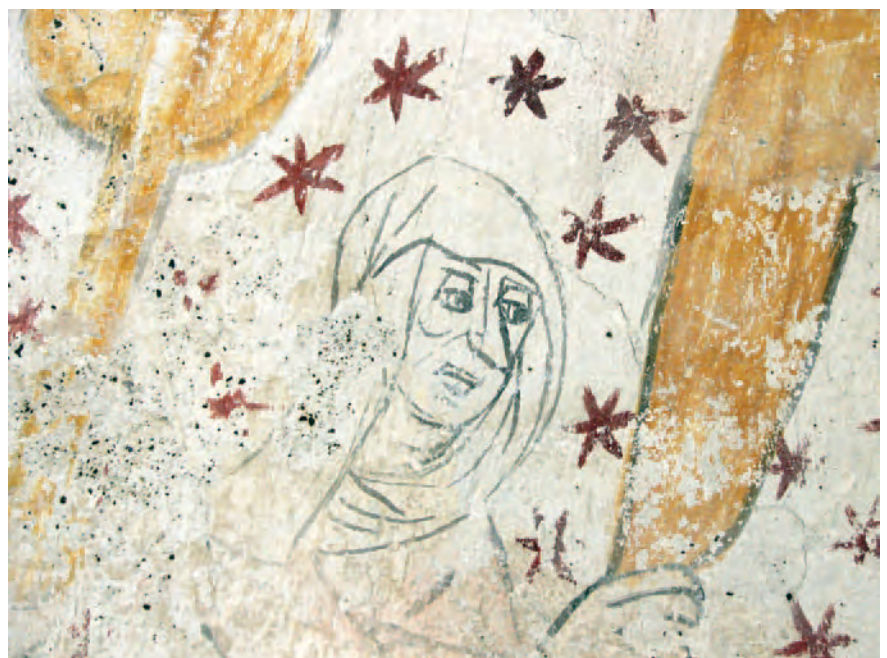
**Figure 2.** Rørby Church. Wall painting in the nave. Condition before restoration. © National Museum, 2006.

Between 1980 and 1982, important Gothic paintings dating from 1425–50 were uncovered in Rørby Church, situated on the western part of the island of Zealand. The paintings were of high artistic value and attributed to the workshop of Undløse<sup>3</sup> (Figure 2). From the very beginning, the church council was enthusiastic and, supported by authorities and consultants, the work was financed. The uncovering and restoration was carried out by the National Museum Conservation Department.

Unfortunately, shortly after the restoration was finished, the paintings began to deteriorate as a result of salt efflorescence. As early as 1983, the National Museum drew attention to the hot-air heating system, which needed to be changed to create a suitable climate. As the church did not have the finances for this solution, the situation grew worse, and the museum frequently made the church council aware of the situation. Not until 1998 was a new heating system introduced, but no funding was provided for the preservation of the paintings. In 1999, the church council agreed to the installation of a climate chamber under the vault, which has reduced the speed of the deterioration. Since 1983, there had been several negotiations between the church council, the church authorities and the National Museum but all efforts broke down, not only due to the lack of money, but also due to the lack of understanding of the heritage value. In this case,
