The cultural heritage of Marathwada

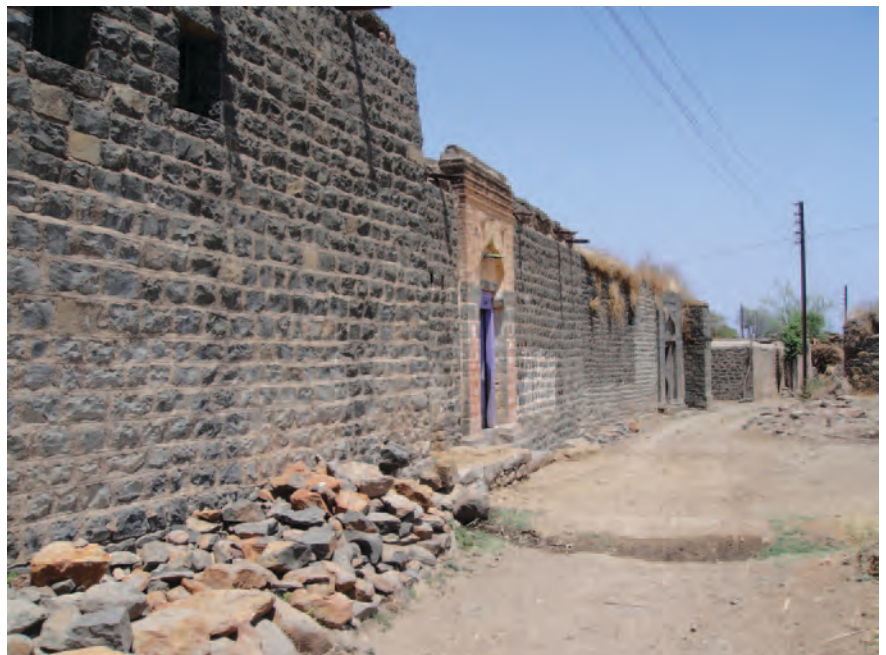
Figure 1. Traditional houses in the region are characterized by massive stone masonry walls, punctuated by large gateways.

Local housing has traditionally been built using the most easily available local materials, including stone and wood. Typically, the walls are made of stone masonry, sometimes more than 600 mm thick with mud or lime mortar (Figure 1). In villages where there are large deposits of white clay soil nearby, walls are predominantly made of adobe bricks produced from that soil. The most commonly found type of roof construction consists of timber with a thick heavy layer of soil to provide waterproofing and insulation. There is a distinct typology of housing based on the economic and social status of the household. Houses of wealthy people are characterized by a courtyard surrounded by a colonnaded veranda off which the rooms are arranged. A front wall with dressed stone cladding and a massive doorway are also characteristic features of these houses. Other important elements of the built heritage are stone temples with typical pyramidal roofs (Figures 2 and 3), cave temples, fortresses, and wells and water tanks representing a well-developed traditional water system. The region also abounds in
